# CASE STUDY:

## CITY OF ROCKY MOUNT TIPPING FLOOR REPLACEMENT

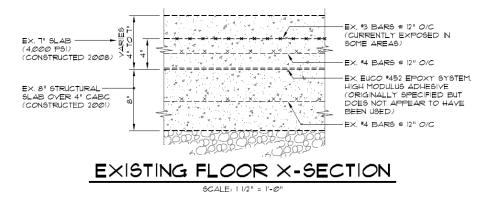
The original base concrete was installed in 2001, with an additional top concrete slab placed in 2008. The reinforced top slab was to be bonded to the existing substrate slab with epoxy adhesive. In spring of 2008, the bonded 7" slab was installed on top of the underlying 8" structural slab, at an approximate cost of \$88,000, or \$16/sf.

In 2012 the City began to notice that the floor showed significant signs of wear after just four (4) years of use. Large areas of the top slab had eroded 3" in depth, so that that reinforcing steel was exposed and in some places protruding dangerously. Almost 25% of the floor became severely eroded so the City installed an asphalt patch for temporary repair. The push wall also needed repairs, as the structural attachments had pushed through the wall leaving holes.

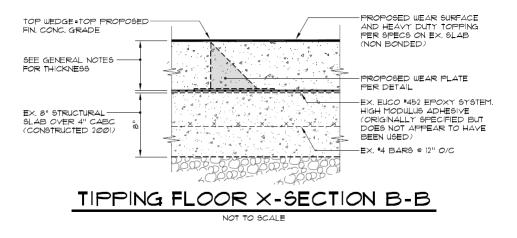
The typical section below shows the proposed floor section for bidding, though it was revised during construction.

Appian prepared a bid package and plans to remove and replace the existing 7 inch solid waste tipping floor and install a 6-inch wear course. The bid package was structured to enable bidders to provide an alternate design/build method or proprietary concrete slab that would provide adequate wear resistance with 10 to 15 years longevity.

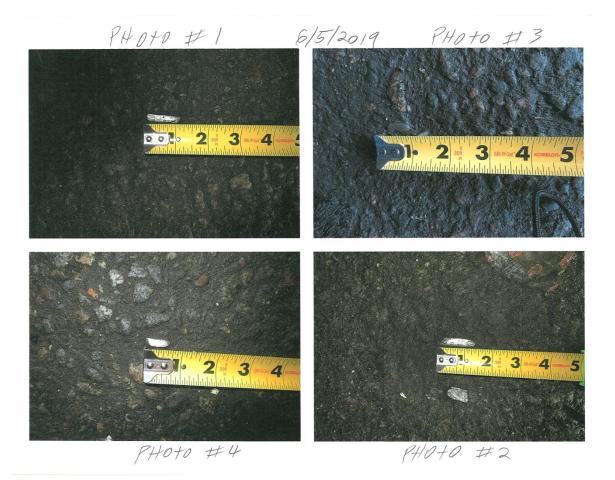
Appian inspected the tipping floor facility in June 2019 to evaluate its performance and found the push wall and tipping floor in excellent condition. We interviewed City staff who said that were very pleased with how the facility was performing, noting that the floor was holding up much better than previous overlay repairs. There was no gouging or areas of concern, even after the City had processed almost 350,000 tons of solid waste since installation of the floor in 2014.

Appian obtained detailed measurements of the wear plates and determined that there was minimal deterioration of the sacrificial wear slab over the past five (5) years.

TIPPING FLOOR WEAR PLATE MEASURMENTS (6/5/19):	
Wear Plate #1	1-1/8″
Wear Plate #2	1-3/8″
Wear Plate #3	3/4"
Wear Plate #4	5/8″

The wear plates indicate that the average deterioration of the new sacrificial floor (6" to 9" concrete slab) was less than 1 inch in the past five (5) years. At the current rate, the projected life expectancy is more than 20 years without the need to replace the floor. If repairs are needed in the future, the floor is designed in such a manner that only the required sections need be replaced, not the entire floor... saving significant expense.
